Bramley Model 26E Electric/Hydraulic Pipe Bender

Bramley Model 026E Electric/Hydraulic Pipe Bender

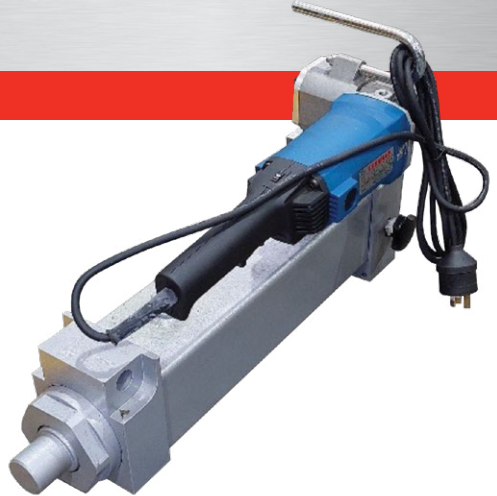
The Bramley 026E Electric/Hydraulic Pipe Bender uses a variable speed motor to drive a cam onto a plunger. This drives the primary piston, sending hydraulic oil to the main ram driving it out.

When the control valve is released the main ram will retract via its internal spring.

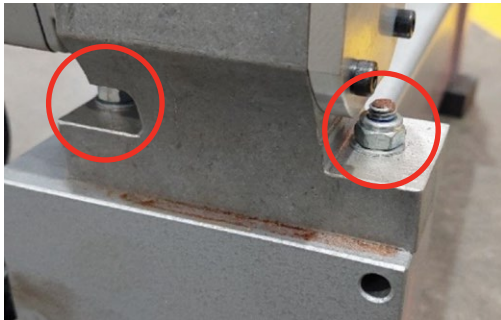
Figure 1: 2x M8 nuts retaining the motor / gearbox unit.

Remove the 2x nuts holding the gearbox/motor unit and separate from the hydraulic unit.

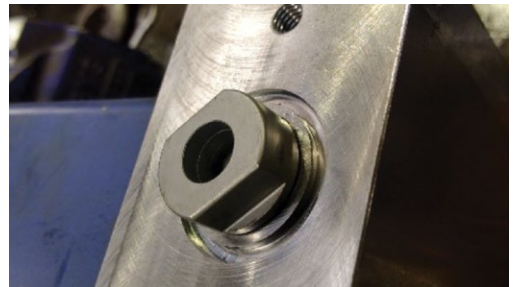
Figure 2: The primary cylinder assembly fitted.

Unscrew this primary cylinder assembly. Remove the piston and inspect the seal, replace as necessary.

Under the cylinder piston assembly is a spring, filter plate and steel ball.

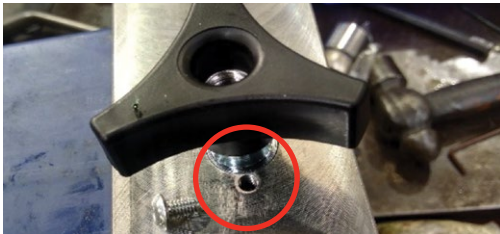
Figure 3: Control valve with retaining screw removed

Loosen the control valve and then undo the retainer screw as shown in Figure 3. This will then allow the control valve to be removed completely.

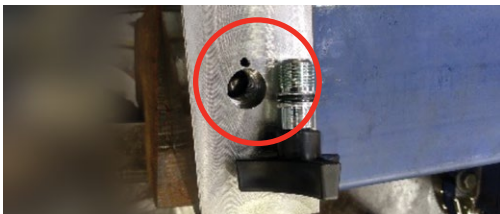
Figure 4: Control valve removed. Note large ball visible in control valve port.

Underneath the control valve you will find a large steel ball, a spring then a small steel ball at the bottom. Note the spring has one end slightly curled inside. This end must go back in against small steel ball.

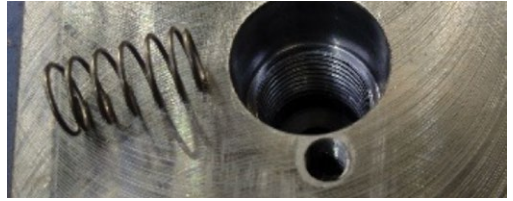
Figure 5: Control Spring removed. Note: in this picture, the right end of the spring is slightly curled in. This end must go against the small ball Figure 6.

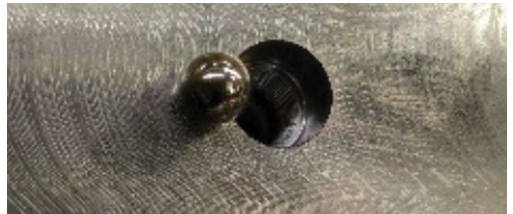
Figure 6: Second smaller ball which locates on the bottom removed

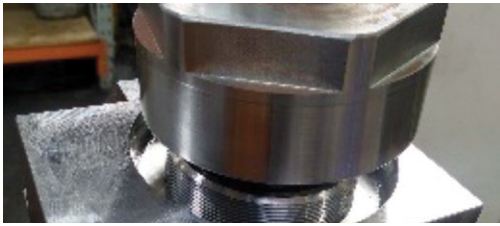
Figure 7: Retaining cap undone

First, remove the Retaining Cap at the front of the unit. These have a 85mm spanner/socket flat on them.

The Retaining Cap nut will be very tight. They are installed to a torque of approx. 2400Nm (1800ft/lb) to resist the pull force against them when the unit is in operation, and to maintain a preload tension to prevent oil leaks from the tank seals.

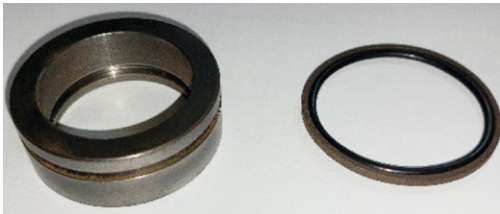
Figure 9: Collar and ram glide seal with its energising O-ring.

Remove the circlip off the end of the ram, slide the piston/collar off the end of the ram.

Check O-ring condition, replace if necessary. Refit collar, ensuring correct orientation as shown in Figure 8.

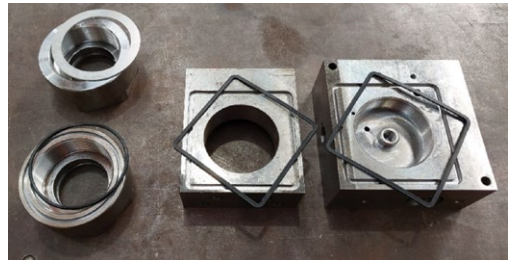
Figure 10: Retaining cap with alley washer, retaining cap with O-ring. Front nose and body with tank seals. (Note: body does not have cylinder fitted).

Between the Retaining Cap and End Collar there will either be an aluminium washer or a O-ring in a groove on the end of the nut (subject to age of the machine – both available as spare parts in the Complete Seal Kit – part number 26-30).

Ensure the tank seals are in their slots and the aluminium washer (if fitted) is free from blemishes.
