Service Manual

Bramley ProBender Ram Repair

Seal Kit part number is 88-P03

The ProBender uses a 50T rated double acting Hydraulic Ram.

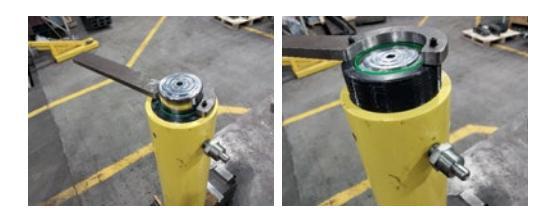
You will need a spanner that engages in two of the holes on the Gland Nut and has clearance around the Ram (as in the image below).

The Gland Nut has a right-hand thread.

Fully withdraw the Gland Nut.

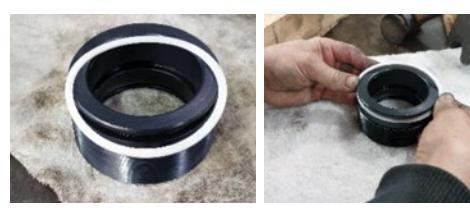
Fit the outer O-ring Backing Ring first. Fit this by hand, do not use tools as the Backing Ring may be easily damaged.

Next fit the outer O-ring, again fit this by hand, do not use tools. O-ring must be fitted with the Backing Ring at the outer shoulder (nearest the threads) of the Gland Nut.

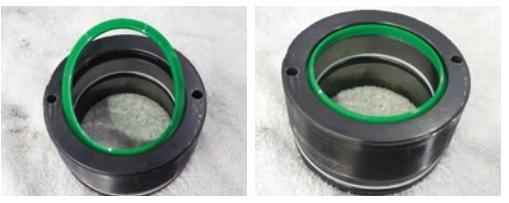
Finally, install the Wiper Seal ensuring the lip of the seal (stepped edge) is facing out of the Gland Nut.

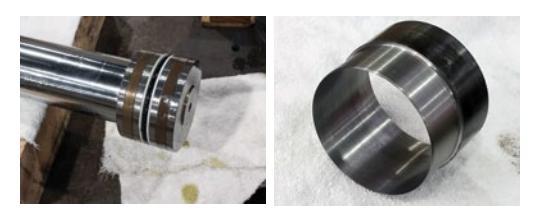
CAUTION: Replacement and refitting of the Ram into the Cylinder will require a special seal guide or use of Steel Shim to protect seals from being damaged by the threads during refitting.

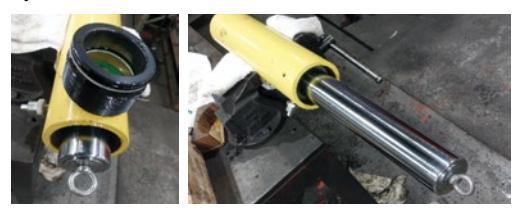
Screw an M10 eye or something similar, onto to front of Ram to enable withdrawing the Ram Spear.

CAUTION: If there is any chance the Piston Seals are to be re-used, they must be protected from damage from the Cylinder thread. Fit a seal guide or use Steel Shim before pulling the piston clear of Cylinder.

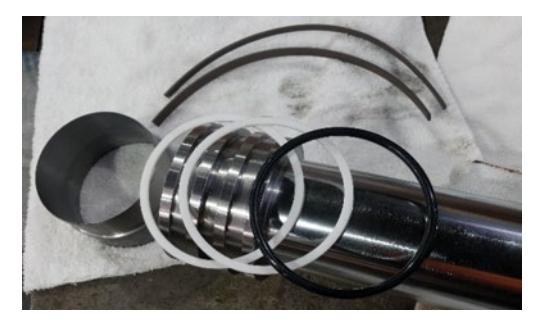
Piston Seals consist of:

2x Seal Backing Rings, 1x O-ring, 2x Wear Strips

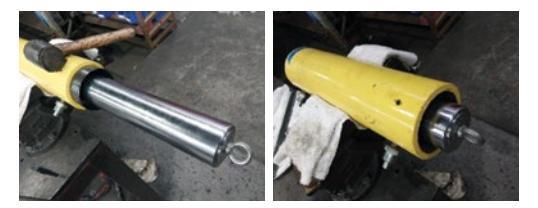
If you are using Steel Shim to reassemble the Ram you will need to install the Steel Shim past the internal thread in the Cylinder, lubricate the inside of the Steel Shim with hydraulic oil, then feed the Ram Spear and Piston assembly into the Steel Shim and Cylinder until the first Wear Strip and the Seal Backing Rings and O-ring are inside the Steel Shim

Supporting the Ram Spear, then install the second Wear Strip and slide the Ram Spear and Piston fully inside the Cylinder, then complete assembly of Ram as detailed.
